# Sligo Park Hills

## Green Streets

<b>Watershed:</b>	Anacostia River
<b>Sub-Watershed:</b>	Sligo Creek
<b>Completion Year:</b>	2015
<b>Impervious Area Treated:</b>	13.8 acres
<b>Maryland DNR Trust Fund Grant Award:</b>	\$3,013,217

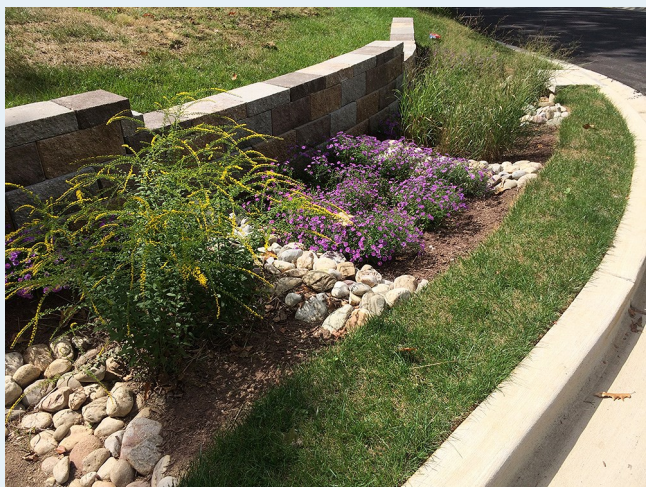
## Bioswale

A low retaining wall was used along one side of this bioswale. Goldenrod and asters combine well in the fall.

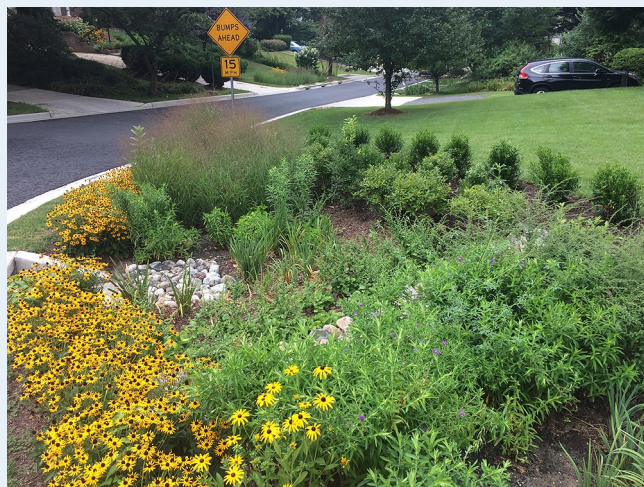
## Bioswale

A large bioswale at a corner is able to treat a larger volume of runoff, and results in a larger garden.

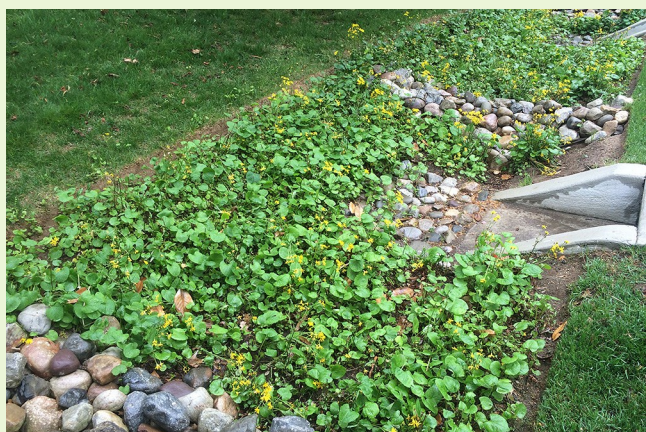
## Bioswale

Check dams in a bioswale slow runoff and allow water to infiltrate into the soil. Golden groundsel blooms in spring.

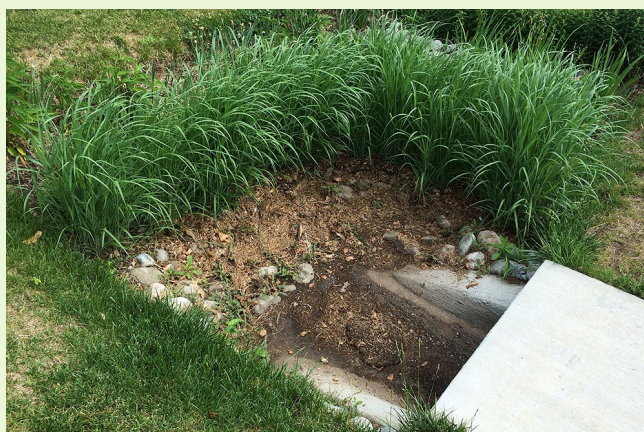
## Bioswale

The dense stems of switchgrass planted around inlets trap sediment and debris, making maintenance easier.

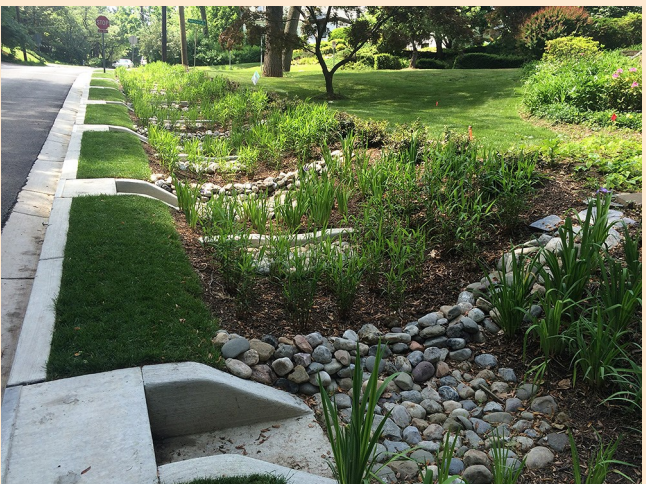
## Bioswale

Check dams and multiple inlets allowed a bioswale to be constructed on a relatively steep slope.

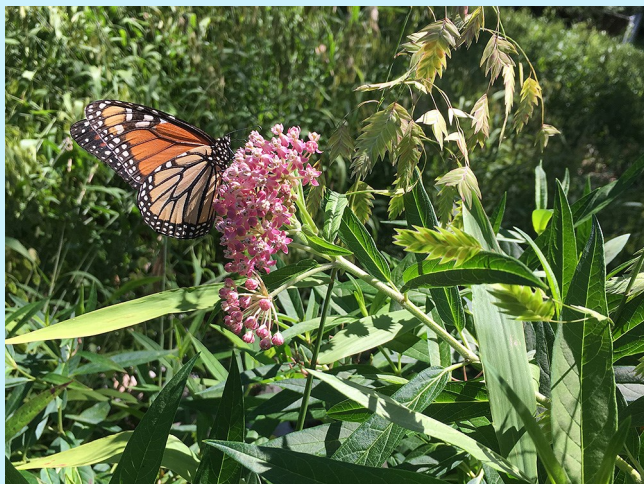
## Habitat Creation

Swamp milkweed and other plantings in the project provide habitat for pollinators such as a monarch butterfly.
